TEST & EVALUATION REPORT
Shingle Regenerator Benchmark Life-Cycle Study

ReGen Roof ReGenerator Study
Page 1 of 10

Report For: ReGen Roof

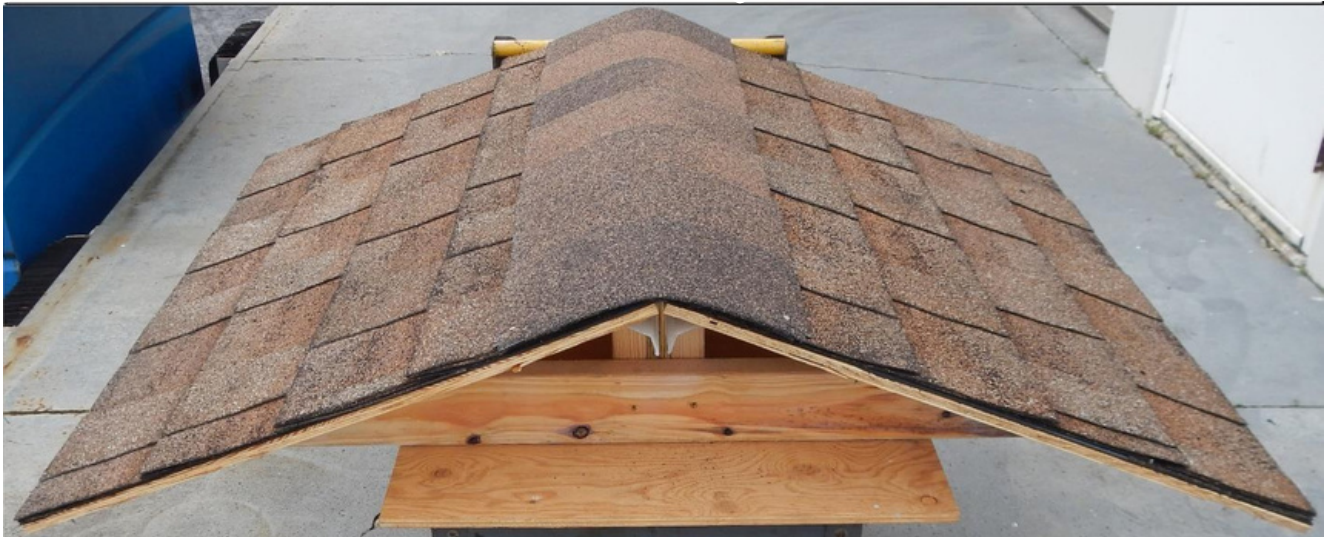
### APPENDIX A-1 (Roof Deck Construction)

#### Completed Roof Deck Before ReGen Roof's Nano Application

A type of common, commercially used ridge-cap shingles were then cut and applied to the cap of the roof deck. The cap was selected for the closest visual match to the shingles used.

The study used a miniature steep sloped roof, constructed at PRI made with commonly used stock material (2X4's, plywood, peel-n-stick underlayment, and stainless-steel roofing nails).

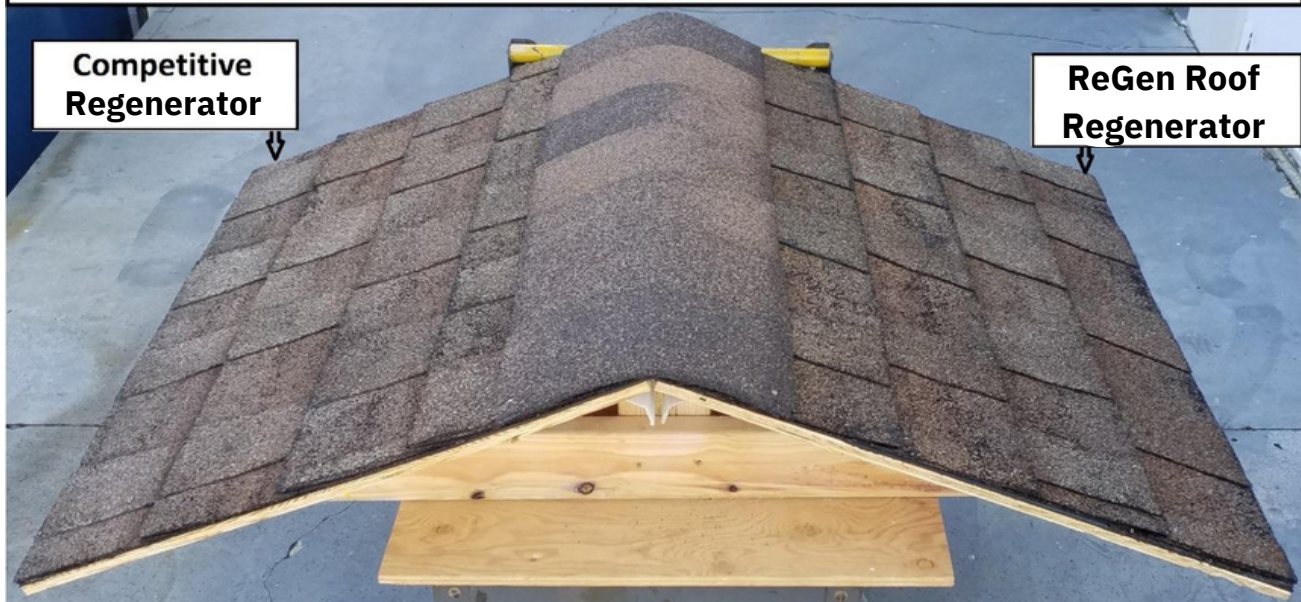
### APPENDIX A-2 (Roof Deck Construction)

# Roof Deck After Regenerator Application

Both Regenerators were prepared and applied according to manufacturer guidelines using common garden spray bottles then allowed to penetrate for 24 hours:

Competitive Regenerator – A mixture of 50% water and 50% Regenerator concentrate stirred by hand to homogeneity.

\*Regen Roof Regenerator – Was a noticeably much more dense concentrate, with the mixture requiring only 30% Regenerator concentrate and 70% water, it was also stirred by hand to homogeneity.

Both products were applied to their respective side of the roof deck at a target rate of 1 gallon per 100ft<sup>2</sup> using spray bottles.

Both slopes were roofed with the aged shingles, with one side being treated with Regen Roof Regenerator Technology and the other side being treated with the leading competitors product found to be much less concentrated. Both were applied according their manufacturer's recommendations. See appendix for photos and details of construction

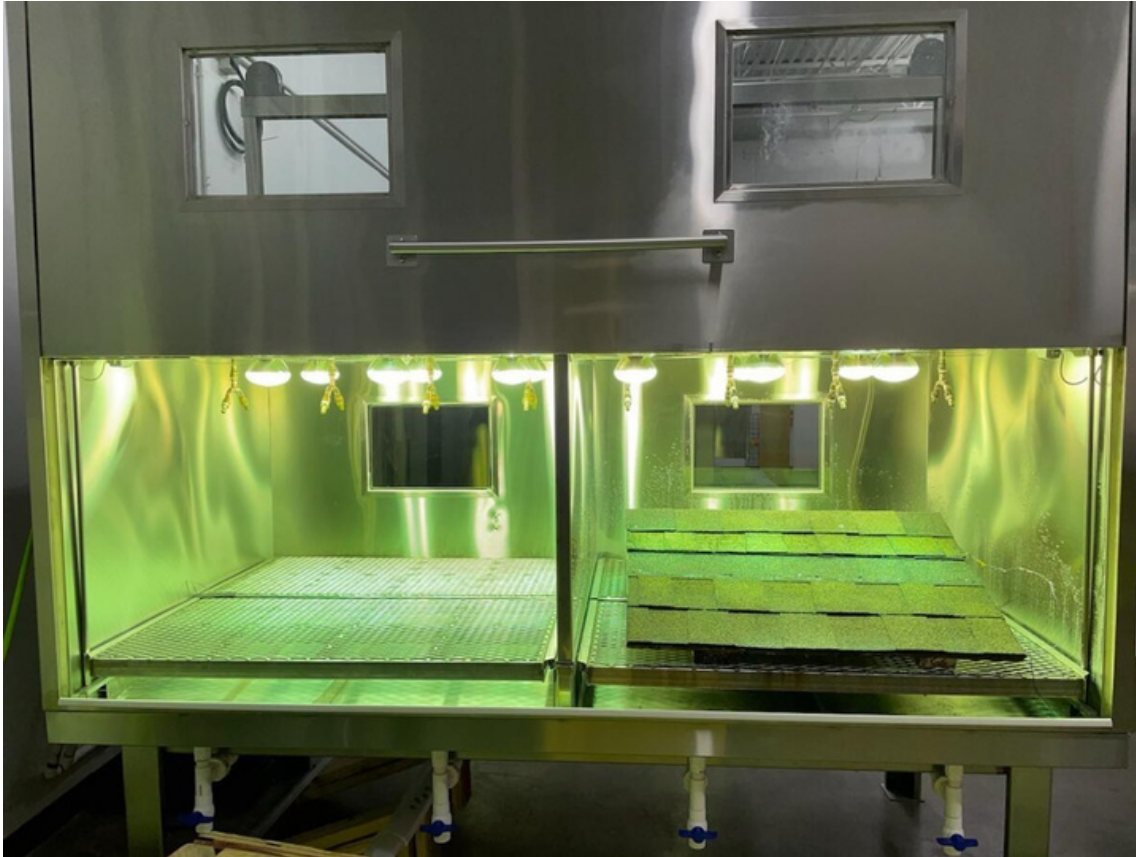
### APPENDIX A-9 (PRI – Asphalt Pavement Weathering System)

**DISCUSSION:** An open view of PRI’s Asphalt Pavement Weathering System with the roof deck positioned in the front chamber (right). PRI’s APWS was used for accelerated weathering of the roof deck after the application and curing of the regenerators. The weatherometer is monitored daily for even light distribution and water spray coverage, while temperature of the chamber, roof surface, water, ambient temperature and relative humidity are all tracked continuously.

The miniature roof was weathered according to ASTM D4798 – "Standard Practice for Accelerated Weathering Test Conditions and Procedures for Bituminous Materials" using a modified exposure cycle consisting of, 51 minutes of light only and 9 minutes of light with rain for 3000 hours.

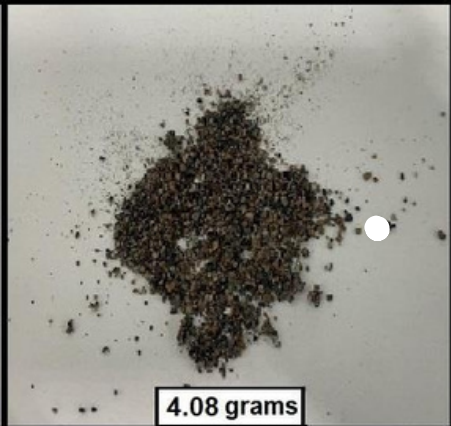
<p>4.08 grams</p>

**DISCUSSION:** Granules and particulate washed from the roof decks after 1500 hours or 5 years of exposure. Particles have been filtered from the accompanying runoff water and dried for quantification.

**Wash Off Material:** The exposure cycles consistently contained particulate material and shingle granules that were washed off by the accelerated weathering process. After 1,500 hours of exposure, the mass of the collected particulate from the untreated shingles was 4.08g, those treated with the competitive Regenerator were 1.78g, and those treated with Regen Roof's Regenerator were 0.70g. Regen Roof's Regenerator performs 5.8 times better than untreated shingles and 2.5 times better than the competition. After 3,000 hours of exposure, the mass of the collected particulate from the untreated shingles was 12.41g, those treated with the competitive Regenerator were 9.86g, and those treated with Regen Roof's Regenerator were 3.94g. Regen Roof's Regenerator performs 3.1 times better than untreated shingles and 2.5 times better than the competition.

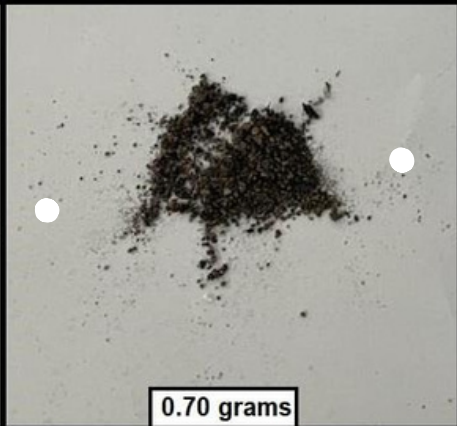
<p>0.70 grams</p>

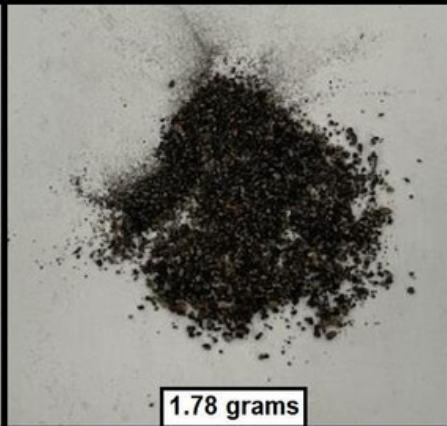
<p>1.78 grams</p>

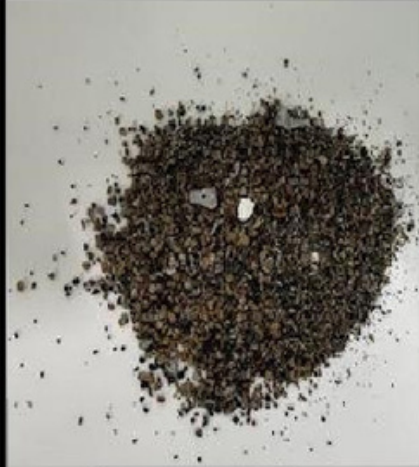
<p data-bbox="240 957 435 991">12.41 grams</p>

**DISCUSSION:** Granules and particulate washed from the roof decks after 3000 hours of exposure. Particles have been filtered from the accompanying runoff water and dried for accurate quantification.

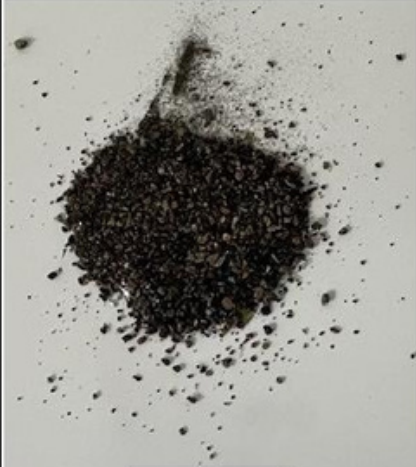
<p data-bbox="699 957 857 991">3.94 grams</p>

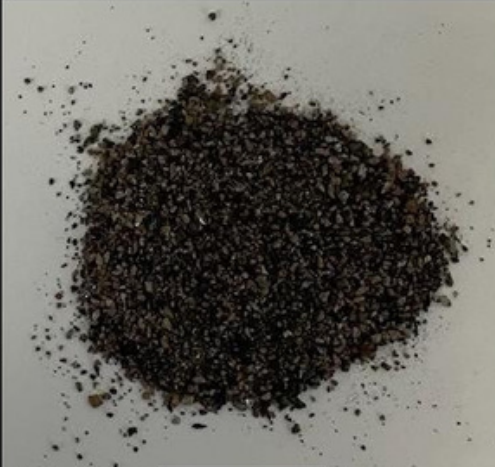
<p data-bbox="1154 957 1312 991">9.86 grams</p>

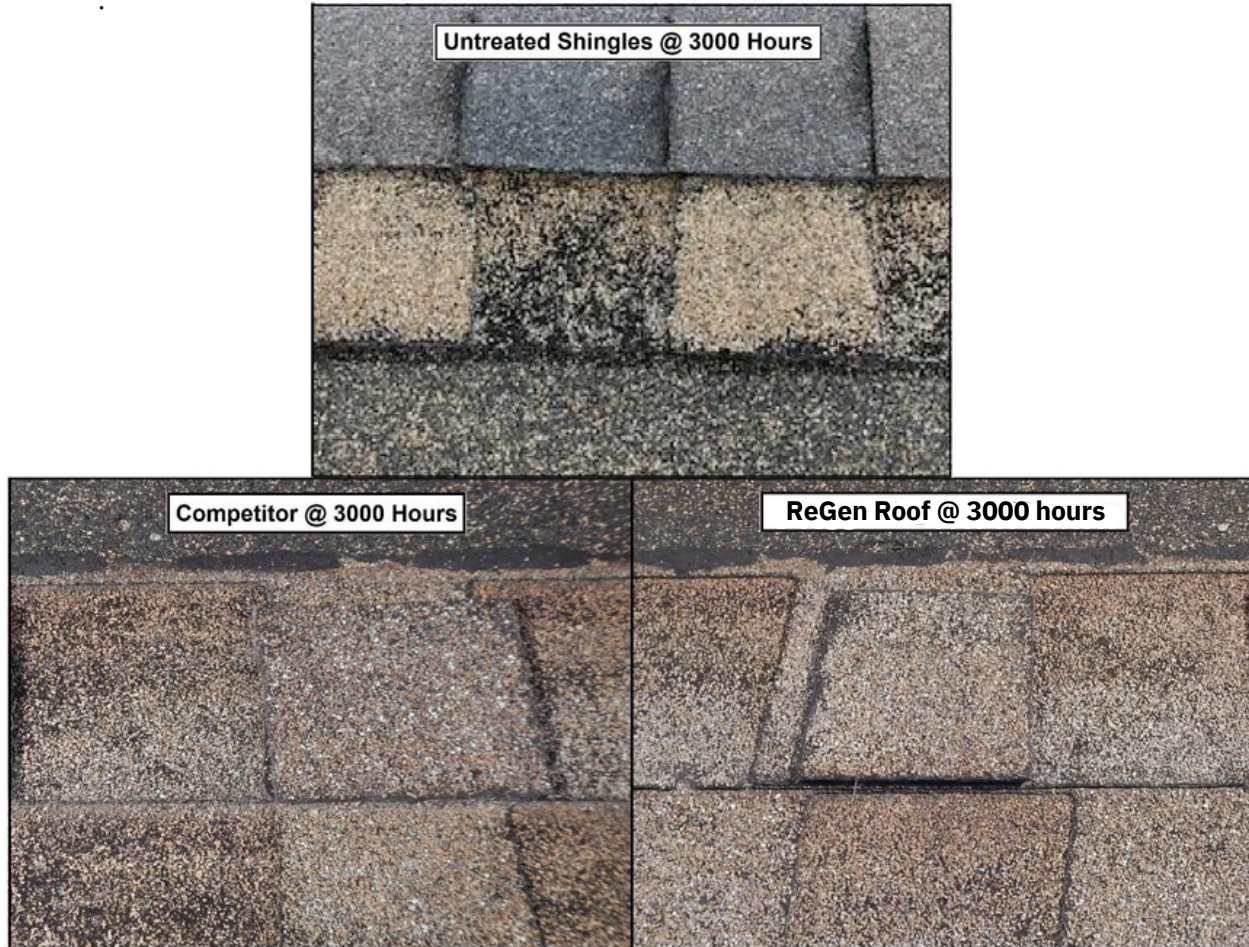
(APPENDIX A-11 (Granular Wash off Comparison – ~3000 hours))

**Close up view of all three sets of shingles after 3000 hours of APWS weathering.**

**Shingle Color and Appearance:** After 3,000 hours of exposure, both Regenerators resulted in shingles that have similar appearances and colors, while the untreated shingles exhibit a notable decline in appearance due to granular loss and fading.
